Operating Experience Weekly Summary 97-10

February 28 through March 6, 1997

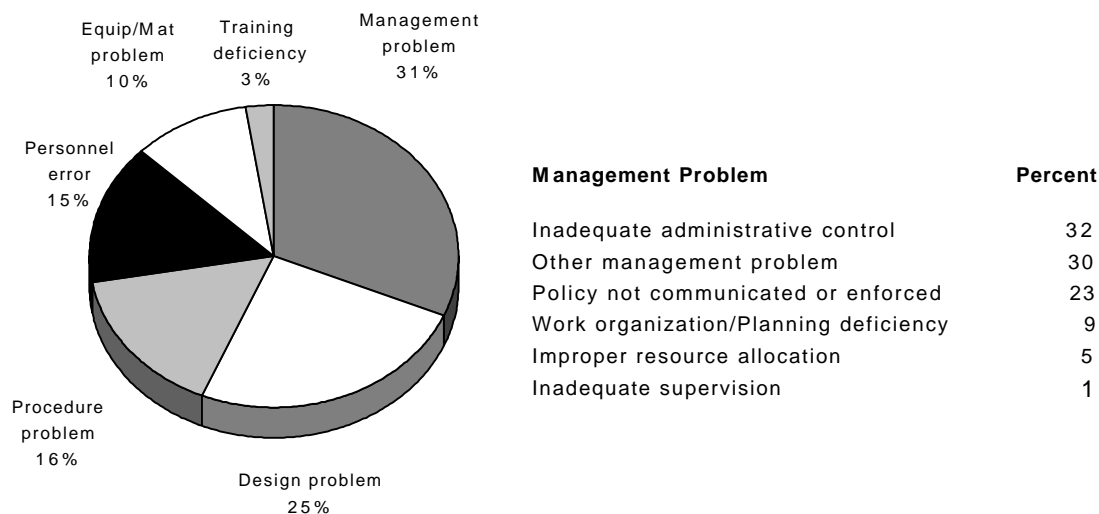
Operating Experience Analysis and Feedback (OEAF) engineers reviewed the Occurrence Reporting and Processing System (ORPS) database for potential unreviewed safety questions across the DOE complex and found 440 occurrence reports. Figure 1-1 shows facility managers reported management problems, design problems, procedure problems, and personnel errors as the major root causes that led to unreviewed safety question screenings. Thirty-two percent of the management problems were the result of inadequate administrative control. Other management problems accounted for 30 percent of the management problems. Other management problems accounted for 30 percent of the management problems.

Figure 1-1. Distribution of Root Causes for All Unreviewed Safety Questions Across the DOE Complex¹

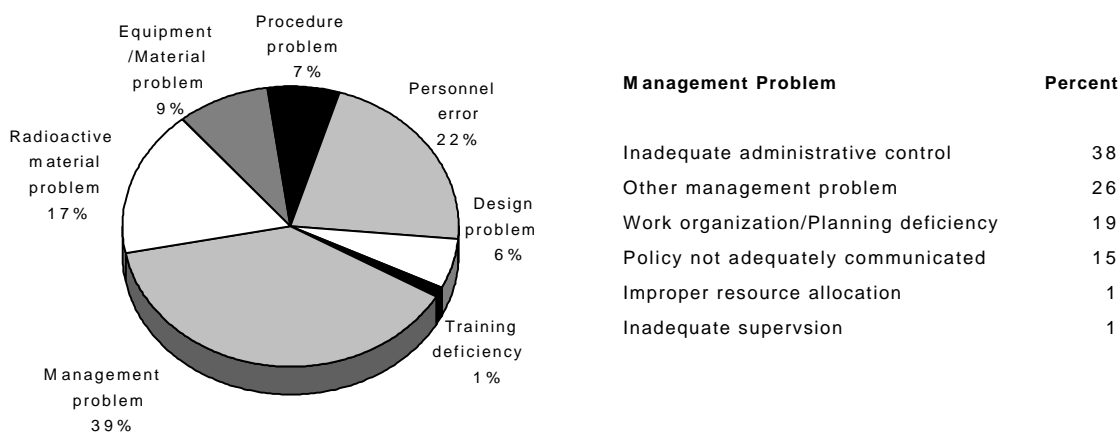
Operating Experience Analysis and Feedback (OEAF) engineers reviewed the Occurrence Reporting and Processing System (ORPS) database for reports with a nature of occurrence code for personnel contamination. Figure 2-1 shows the distribution of root causes reported by facility managers for these events. Personnel error represented 22 percent of the root causes, and management problems accounted for 39 percent. Inadequate administrative control accounted for 38 percent of the management problems.

Figure 2-1. Distribution of Root Causes for Personnel Contamination¹

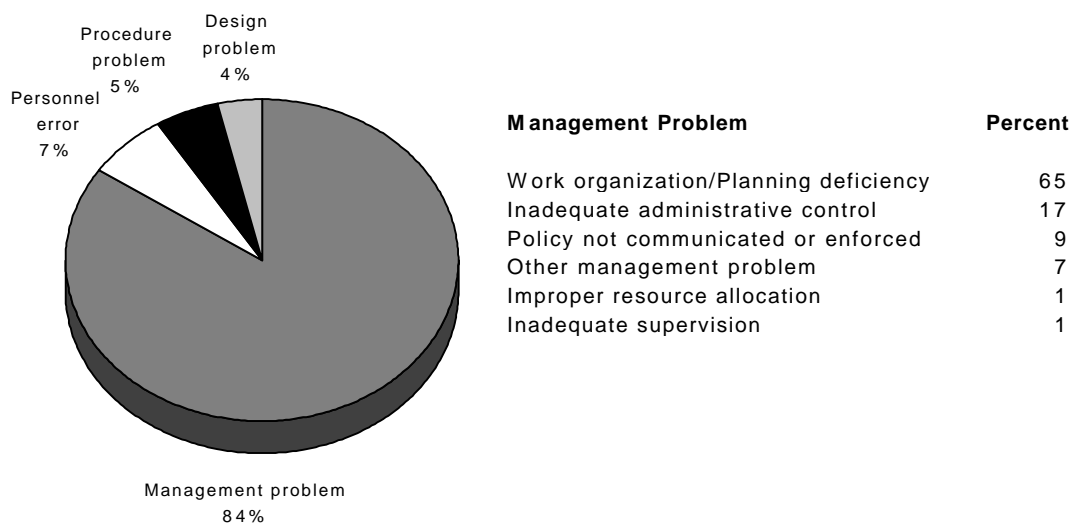
Operating Experience Analysis and Feedback (OEAF) engineers searched the Occurrence Reporting and Processing System (ORPS) database for events with work planning deficiency as the direct cause and found 400 occurrence reports. Figure 3-1 shows facility managers reported management problems as the root cause for 84 percent of work planning issues across the DOE complex. Further review shows that 65 percent of the management problems were reported as work organization or planning deficiencies.

Figure 3-1. Distribution of Root Causes for Work Planning Issues Across the DOE Complex¹
